IL Rte. 1 (Halsted) at 144th Street
Riverdale, IL

- RLR Photo Enforcement System monitors violations occurring on the northbound approach of the intersection
- RLR Photo Enforcement System installed: February 23, 2009

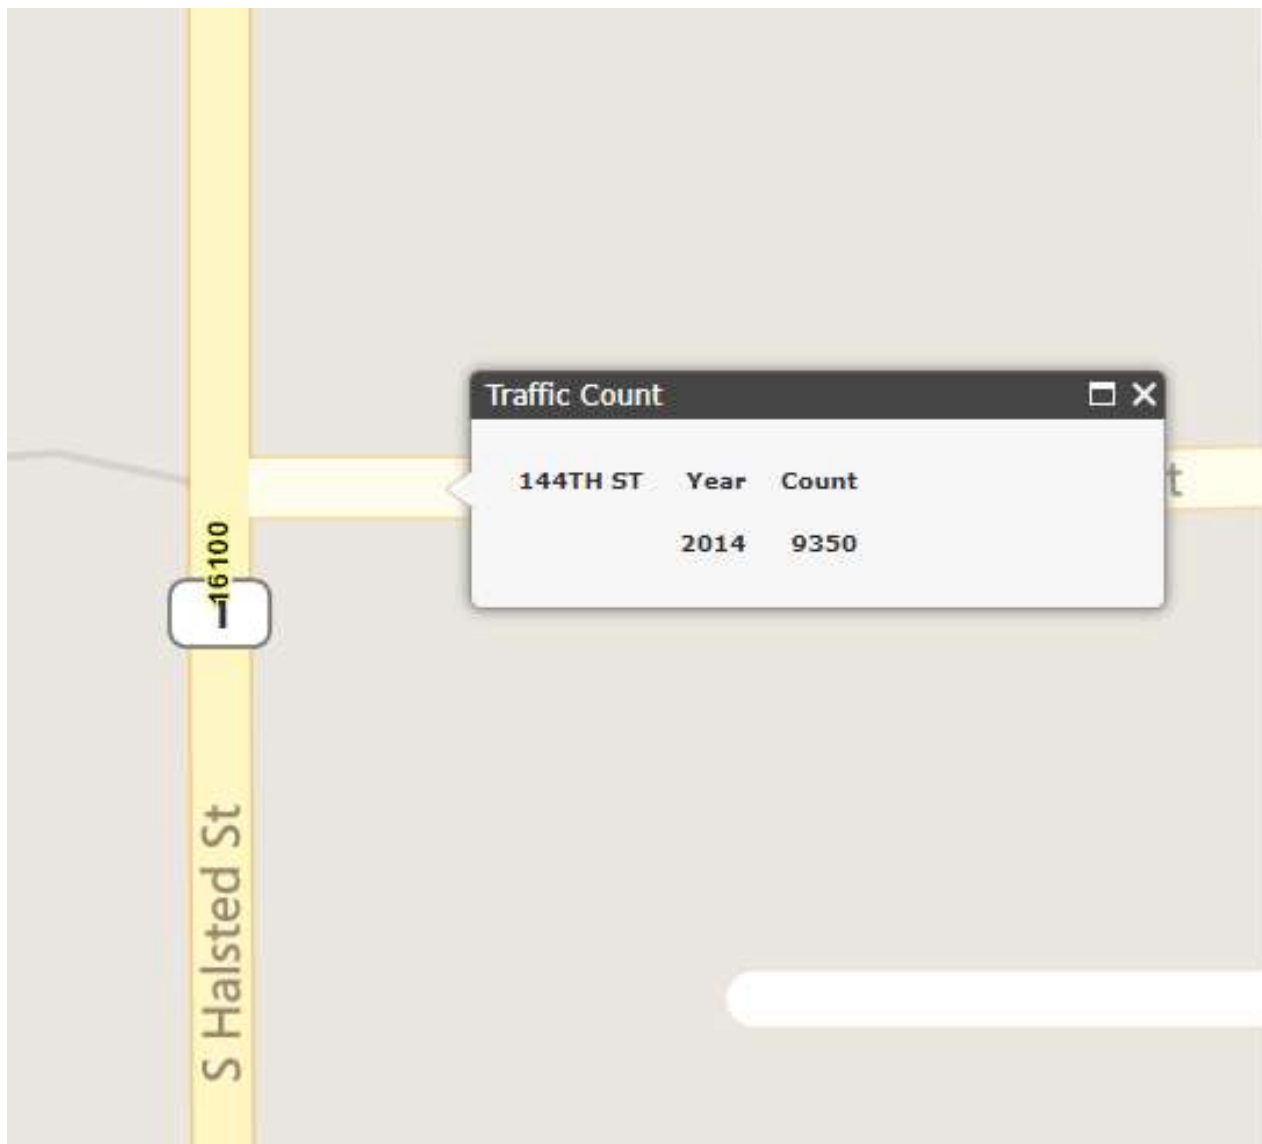
Average Daily Traffic

IL Rte. 1 (Halsted) at 144th Street (Westbound)

- 9,350 (2014)
